Lake Braddock Secondary School Walkabout Report

Introduction

On November 17, 2022, stakeholders at Lake Braddock Secondary School (LBSS) in Burke, Virginia met to discuss conditions for walking and bicycling to school and identify potential projects to be included in a future infrastructure grant application. Their participation in a VDOT Safe Routes to School (SRTS) Walkabout shows their support for improving the walking and bicycling environment and increasing the number of students safely walking and bicycling to school.

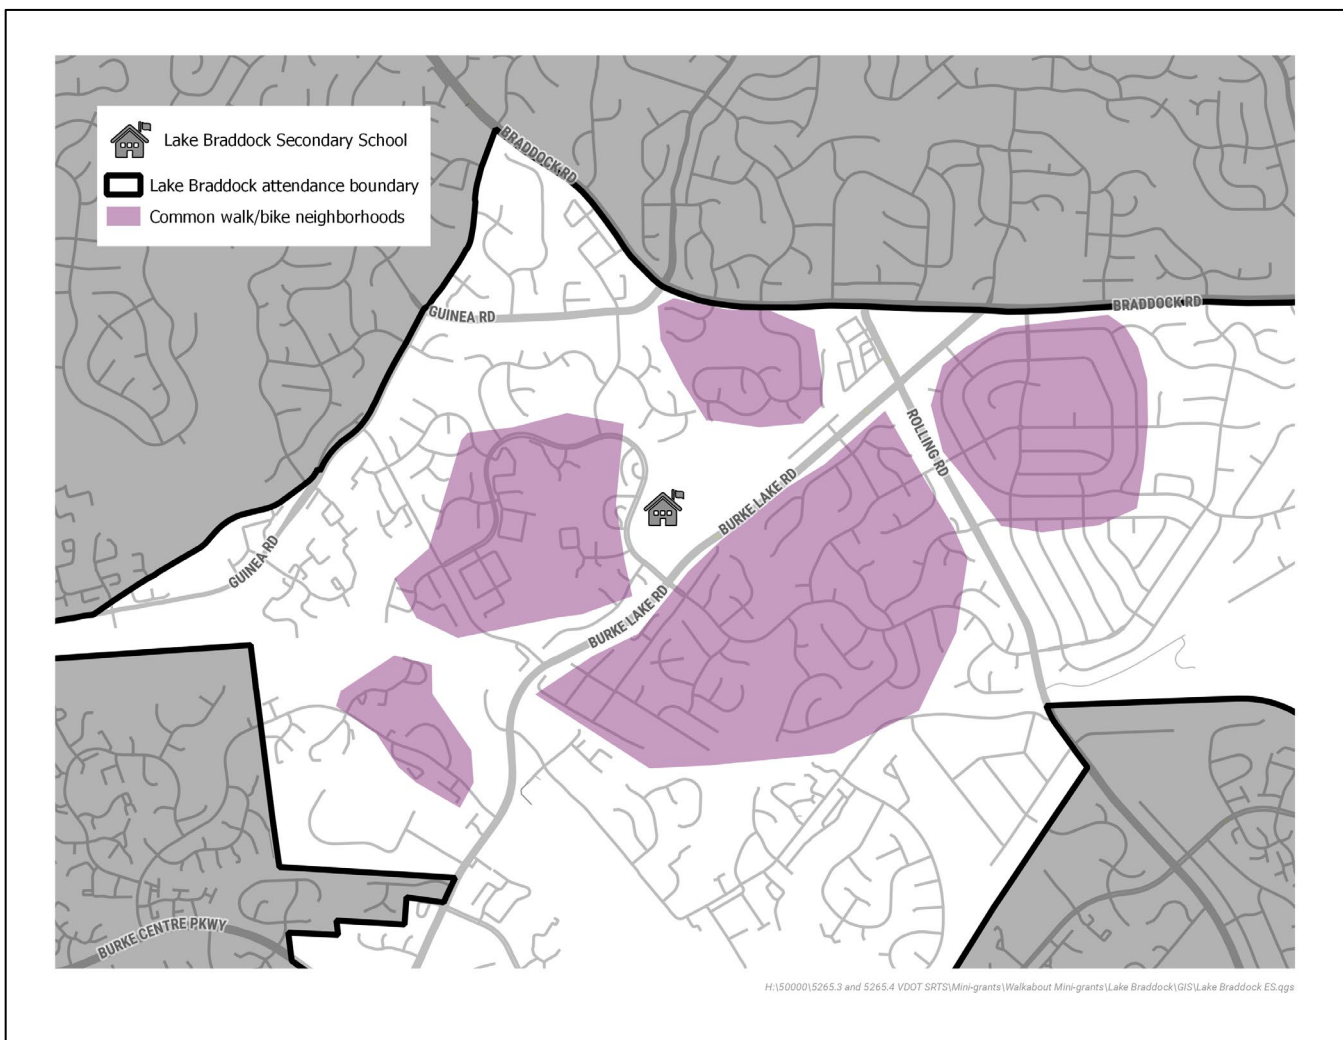
Figure 3: Map of Lake Braddock attendance boundary with neighborhoods most student pedestrians and bicyclists come from highlighted in purple.

According to a survey conducted in April 2022, approximately 10 percent of students travel to school as a pedestrian or bicyclist and 13 percent travel from school as a pedestrian or bicyclist. Students who walk or bike generally live in the areas highlighted in purple in Figure 3.

Nevertheless, 1,128 students (25%) live within one mile of the school, a comfortable walking distance, and 2,549 (58%) live within two miles, a comfortable bicycling distance, suggesting substantial potential for increasing the number of students who walk and bicycle to school.

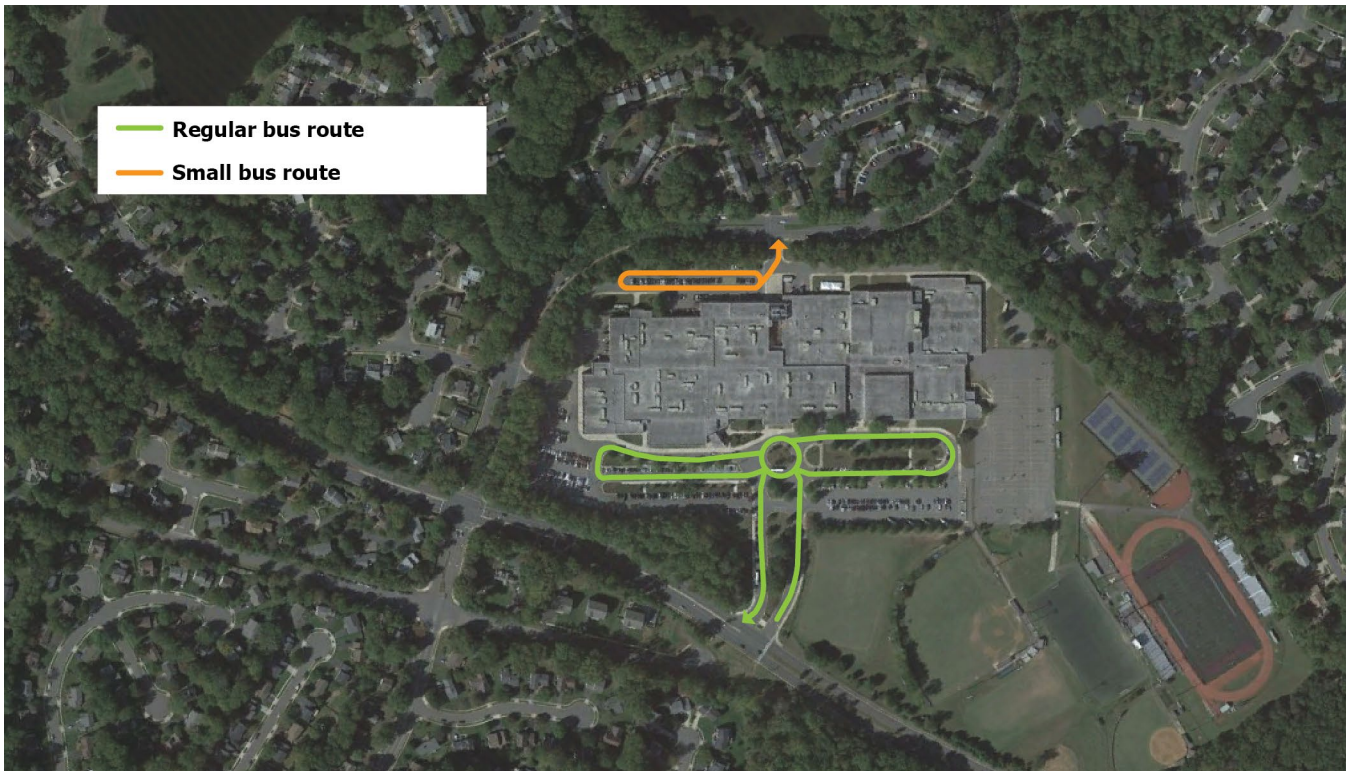
Figure 5. Bus Circulation

Bus Riders: LBSS is served by 55 buses. Most buses pick up at in the parking lot in front of the school off Burke Lake Road. These buses exit to Burke Lake Road via the school's main driveway. Three small buses pick up special education students at the back of the school. These buses exit via Lake Braddock Drive, where they are required to turn right. (Figure 5)

Bus drivers and school faculty are in constant communication via handheld transceivers (walkie-talkie). Drivers receive the go-ahead to depart a few minutes prior to 3 PM and take approximately 5-7 minutes to completely leave the school premises.

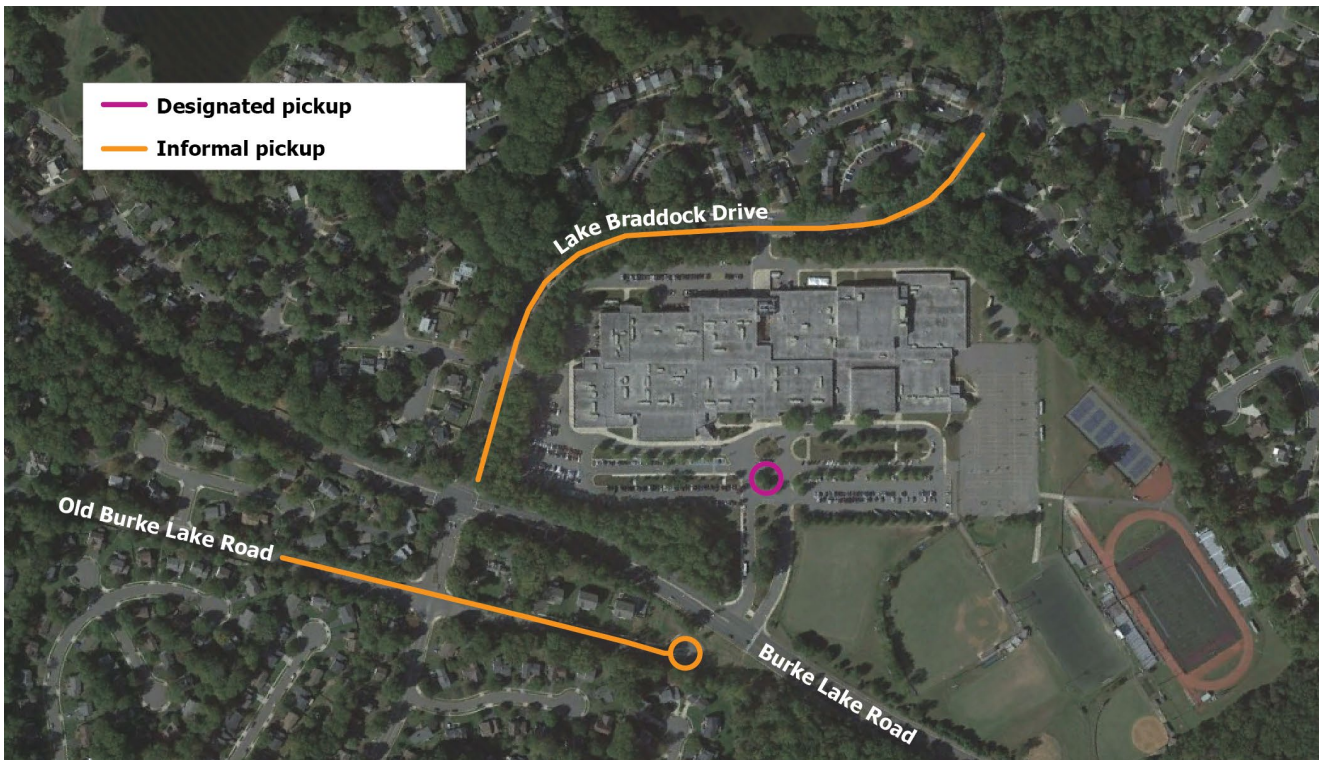
Figure 6. Student pick-up locations

Car Riders: LBSS instructs parents and guardians to pick up car riders near the “Purple Bear” roundabout inside the main entrance off Burke Lake Road. Some arrive as early as 45 minutes to an hour prior to the dismissal bell.

According to members of the Walkabout Team, some parents and guardians prefer to pick their students up off-campus. These usually park on Lake Braddock Drive, if parking is available, or on Old Burke Lake Road.

Figure 6 shows student pick up locations.

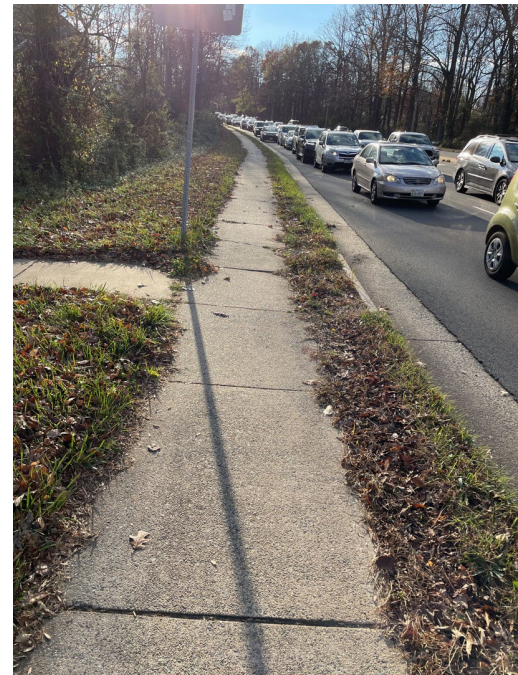
Figure 8: Traffic on Burke Lake Road at dismissal.

LBSS's size means that small shifts in student and staff travel mode choices can have significant impacts on nearby streets. The pandemic resulted in a shift away from students using school buses for school transportation and toward students being driven or driving themselves, resulting in additional vehicular traffic around the school. The increase in traffic has amplified parent concerns about the safety of student pedestrians and bicyclists accessing the school, resulting in a vicious cycle of the perceived lack of safety of pedestrian and bicycle travel resulting in more driving. There is now so much car traffic that school buses are often blocked from entering the school campus at arrival, there are backups on main roads, and students routinely arrive late. Parents who drive their kids to school report they would be interested in trying transit buses, alternate drop off points, or carpooling. The school is exploring these alternatives but has yet to officially promote them.

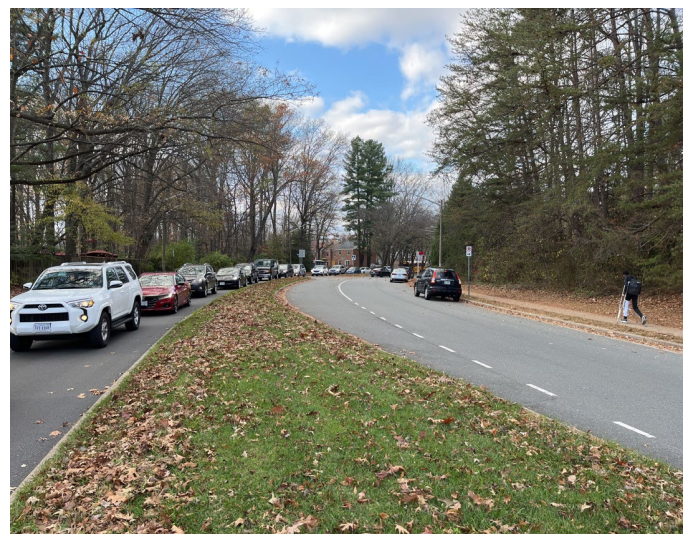
Figure 9: Traffic on Lake Braddock Drive at dismissal.

As a secondary school serving grades 7-12, a portion of LBSS's school population is eligible to drive. Teen drivers ages 16-19 are almost three times more likely than drivers over 20 to be involved in a fatal crash per mile driven.¹ As a result, street designs that encourage safe driver behaviors, driver safety education, and measures to encourage and enable the use of safer alternatives to driving are particularly important for schools such as LBSS with teen drivers.

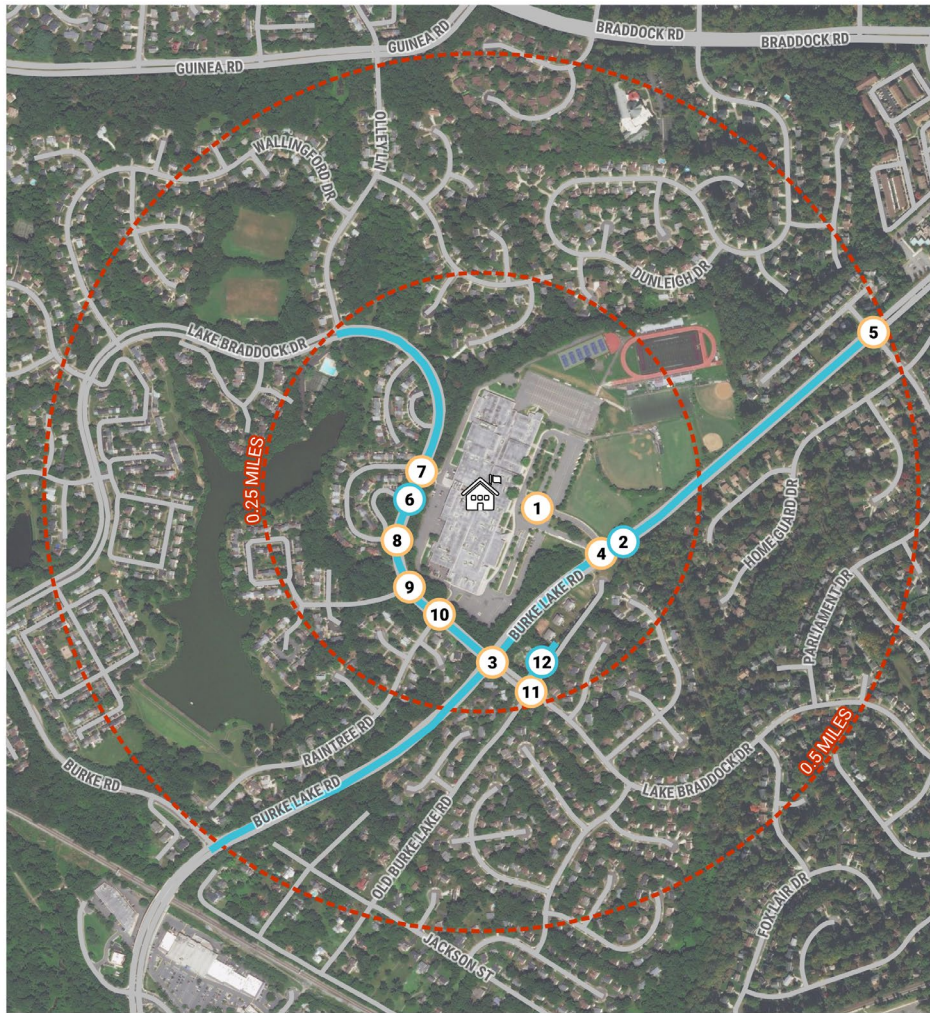
Figure 10: Location-Specific Recommendations

The map below (Figure 8) shows the locations of key recommendations to improve the walking and bicycling environment near LBSS. Recommendations are categorized as corridor or intersection improvements.

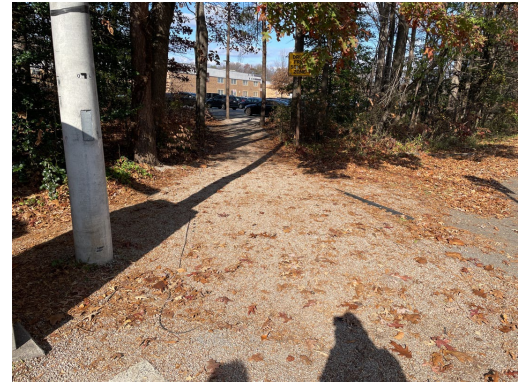
Figure 11: Gravel path between intersection of Burke Lake Road and Lake Braddock Drive.

- Establish a clear, accessible pedestrian access route between the Burke Lake Road/Lake Braddock intersection and the school's main entrance.
- Construct ADA compliant curb ramps to make all marked crosswalks accessible.
- Construct sidewalks on the islands to create complete, accessible connections to parent pick-up location.

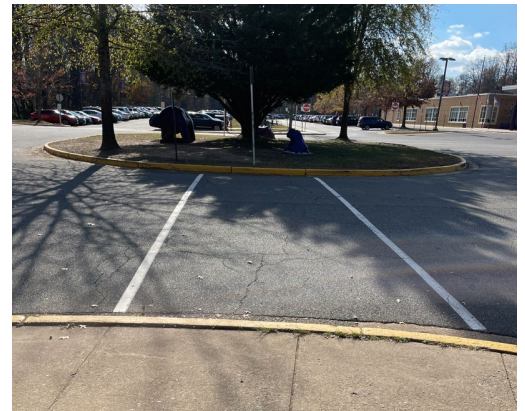
Figure 12: The pedestrian route between the school building and the parent drop-off/pick-up location.

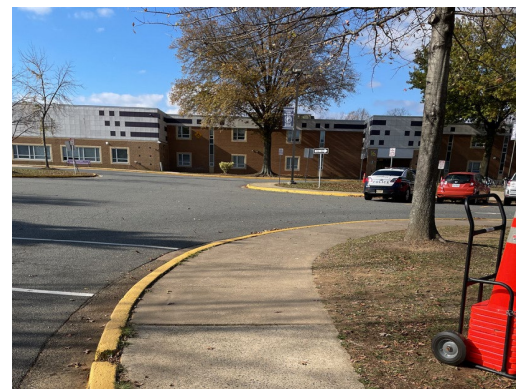
Figure 13: Pedestrian route between the Burke Lake Road/main access driveway intersection and school building.

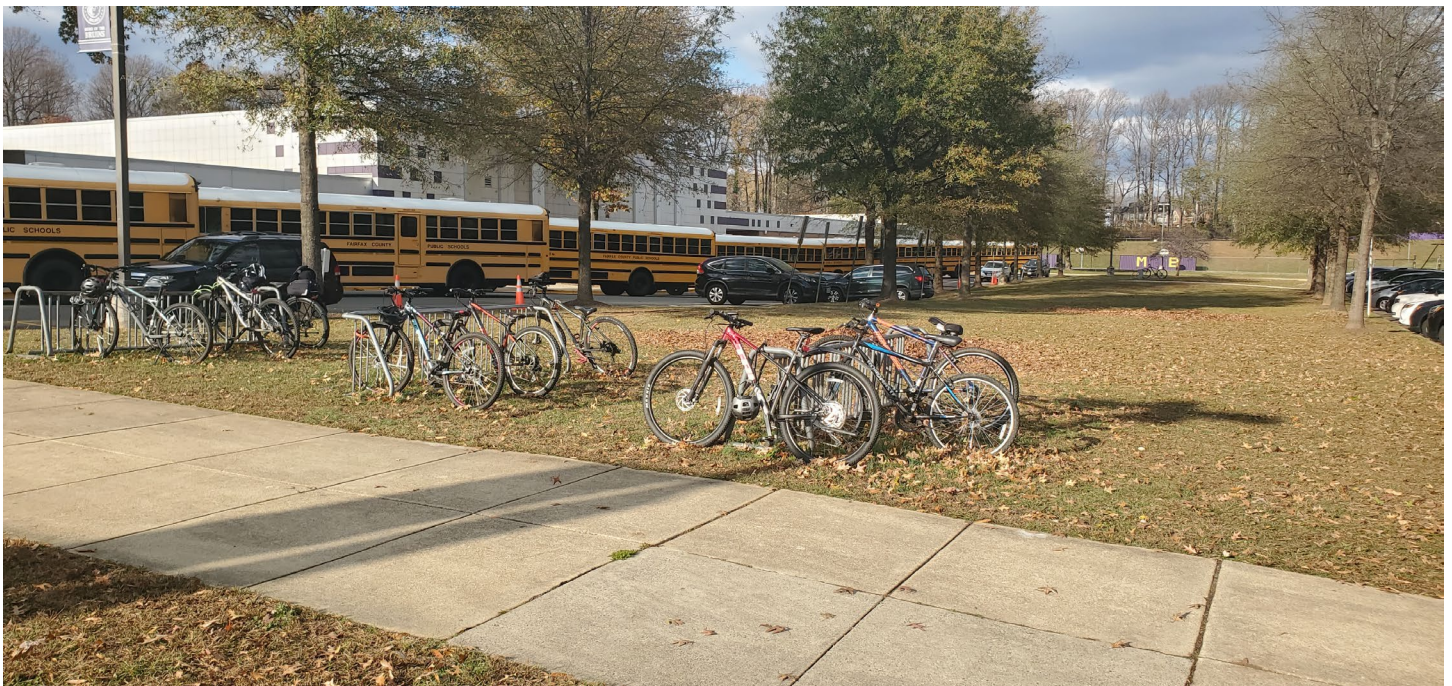
Figure 14: One of nine bicycle parking locations at LBSS.

- Add an additional 180 covered bicycle parking spaces.

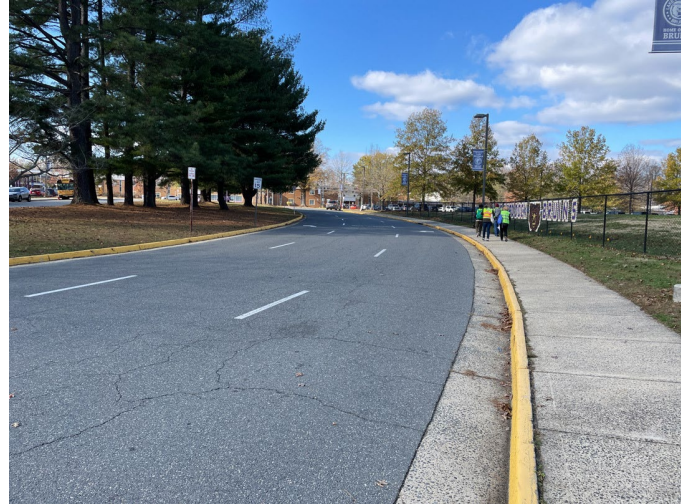
Figure 15: There are concerns about motor vehicle speeds on the school's main access driveway.

- Consider eliminating one motor vehicle travel lane on the entrance and exit driveways and reallocating the space for separated bike lanes or paths, or bus-only lanes.

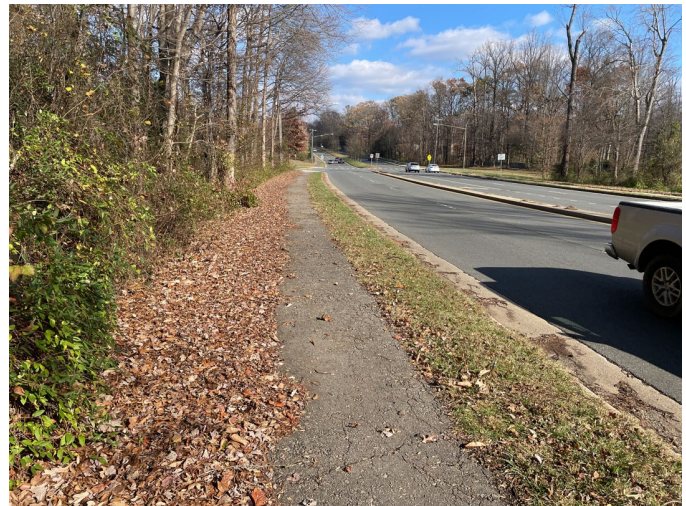
Figure 16: The shared use path on Burke Lake Road is approximately 6' wide.

- Expand the shared use path adjacent to school property to 12 feet wide. Bi-directional shared use paths should be at least 10 feet wide per the forthcoming AASHTO Bike Guide. A width of 12 feet is recommended in this case due to expected peak hour pedestrian and bicyclist volumes.

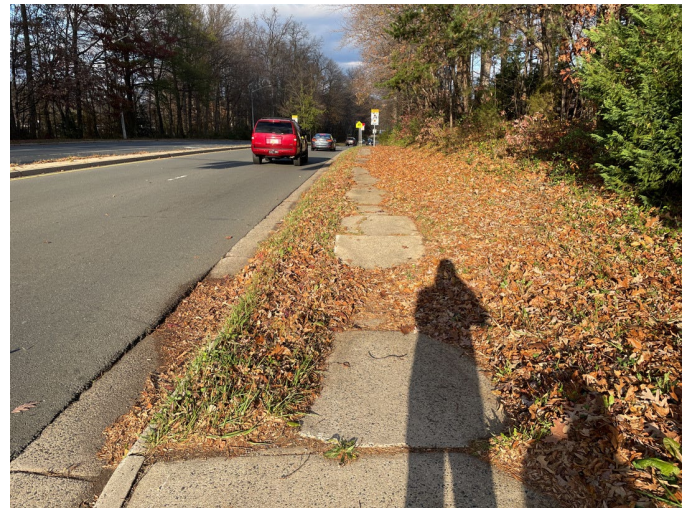
There are several sidewalk repair and maintenance issues along this segment (Figure 17). These issues make it difficult for people in wheelchairs, people with strollers, and others to traverse the sidewalk.

Figure 17: The sidewalk on the south side of Burke Lake Road is obstructed by leaves. There are also vertical discontinuities in the sidewalk that make it inaccessible.

- Address sidewalk repair issues along this segment.
- Establish an adopt a sidewalk program in which student organizations pledge to clear sidewalks adjacent the school of debris and vegetation on a regular basis.
- Distribute flyers to property owners near the school campus reminding them to be a good neighbor and fulfill their responsibility to ensure that sidewalks adjacent to their properties are free of overhanging vegetation, snow, and debris.

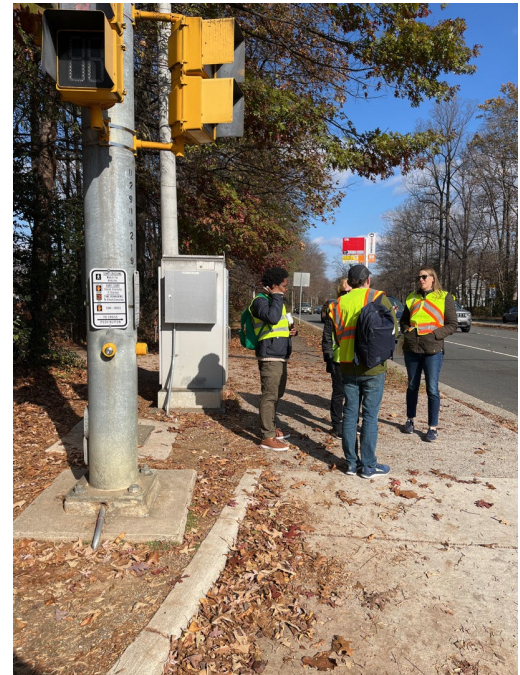
Figure 18: Pedestrian pushbutton is not accessible to people who use wheelchairs.

- Increase the length of the WALK interval for the Burke Lake Road crossing. The minimum required by the Manual of Uniform Traffic Control Devices (MUTCD) is 7 seconds, but the WALK interval may need to be longer in this case due to pedestrian crossing volumes at arrival and dismissal times.
- Evaluate whether the pedestrian change interval also needs to be increased. According to the MUTCD, the pedestrian change interval should be timed to, at minimum, enable a person who starts crossing at the end of the WALKING PERSON signal indication to complete the crossing while traveling at a speed of 3.5 feet per second. Middle- and high-school age students generally walk slower than this speed when walking in groups, so a pedestrian change interval that is longer than the MUTCD minimum should be considered here.

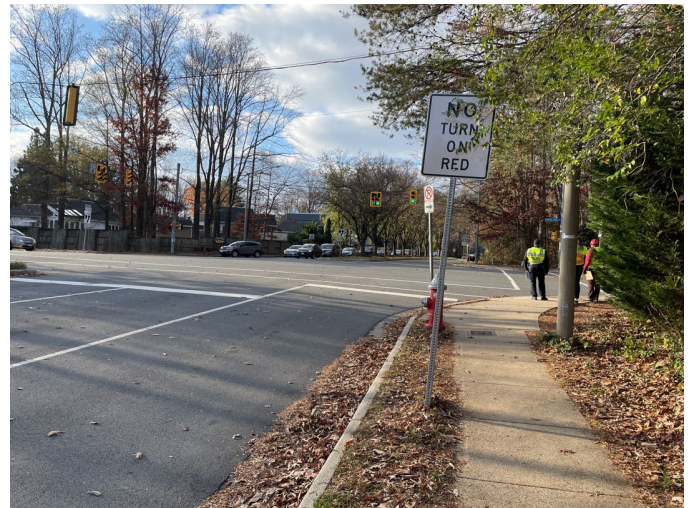
Figure 19: NO RIGHT TURN ON RED signage on northbound Lake Braddock Drive at Burke Lake Road.

- Install SIGNAL AHEAD (W3-3a) signage to warn drivers of upcoming intersection.
- Convert crosswalks to high-visibility and widen to 12'.

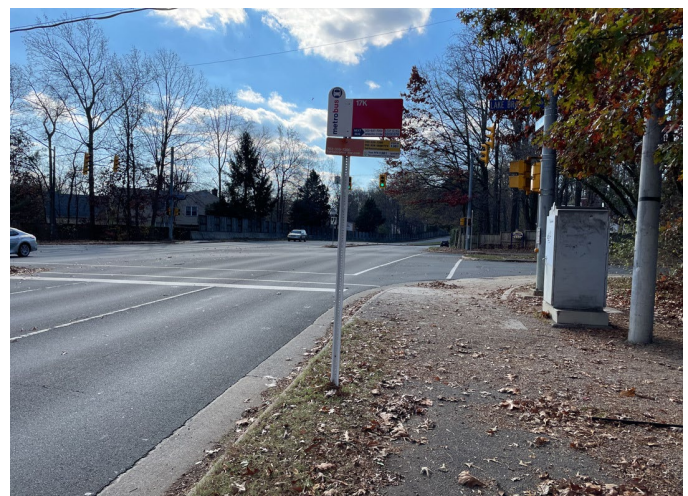
Figure 20: The crosswalks at Burke Lake Road and Lake Braddock Drive are not marked with high-visibility crosswalk markings, making the crossing more difficult to see.

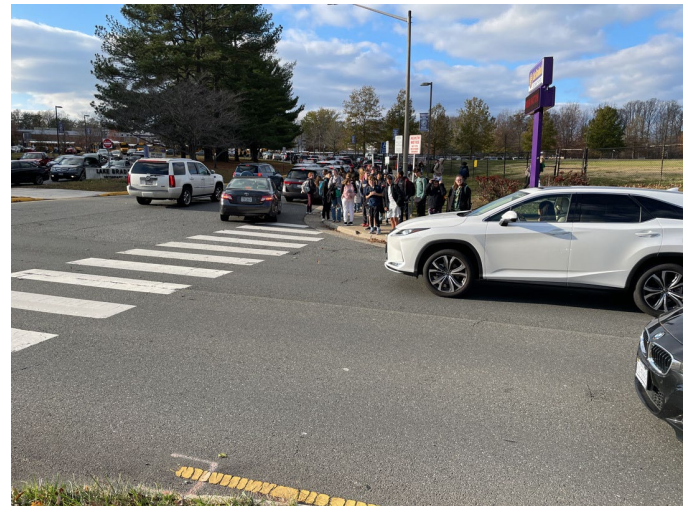
The Burke Lake Road crossing is uncontrolled. Pedestrians must find a gap in fast-moving traffic and cross two lanes of through traffic in each direction. This creates the potential for a multiple threat crash. A multiple threat crash involves a driver stopping in one lane of a multilane road to permit a pedestrian to cross, and an oncoming motorist traveling in the same direction crashing into the pedestrian. Obstructed sight lines between the crossing pedestrian and the oncoming motorist caused by the stopped car are a contributing factor to this crash type.

Figure 21: Students gather on north side of marked crosswalk across Burke Lake Road.

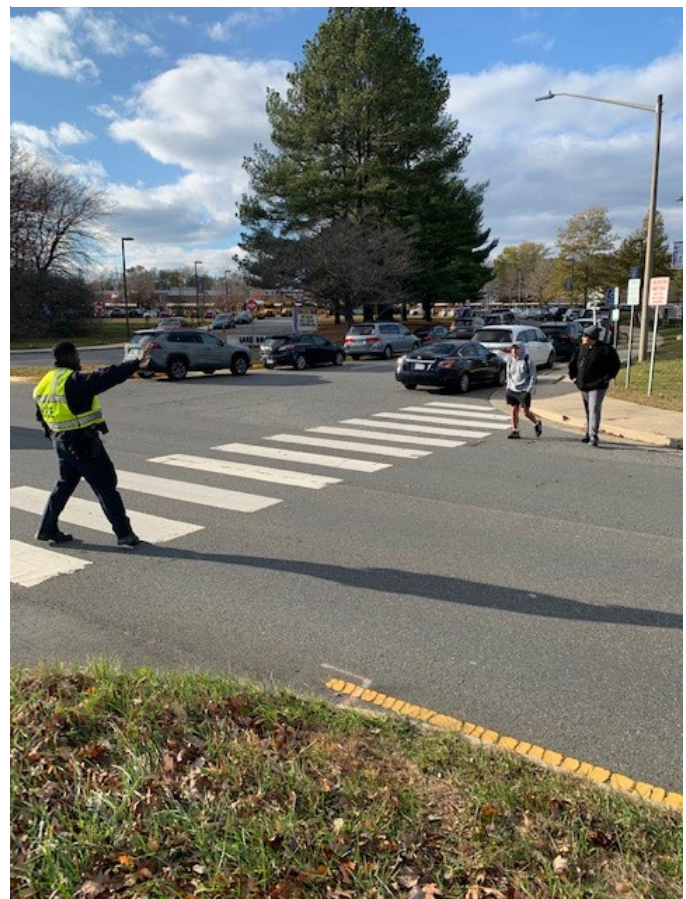
A crossing guard is posted at the intersection during arrival and dismissal times to assist pedestrians crossing Burke Lake Road at this location (Figure 22) but is not present at other times. Many students participate in afterschool activities when the crossing guard is not present, and the school also hosts activities in the evenings and on weekends.

Figure 22: A crossing guard assist students crossing Burke Lake Road at arrival and dismissal times, but many students participate in afterschool activities.

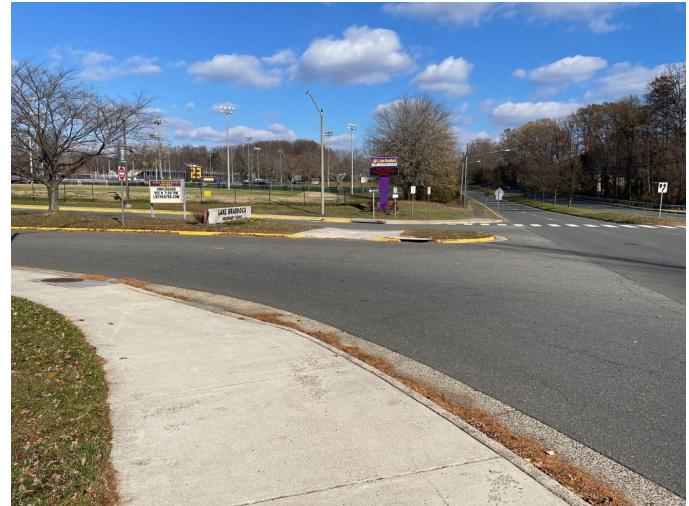
Figure 23: The crosswalk across the school main access driveway is unmarked.

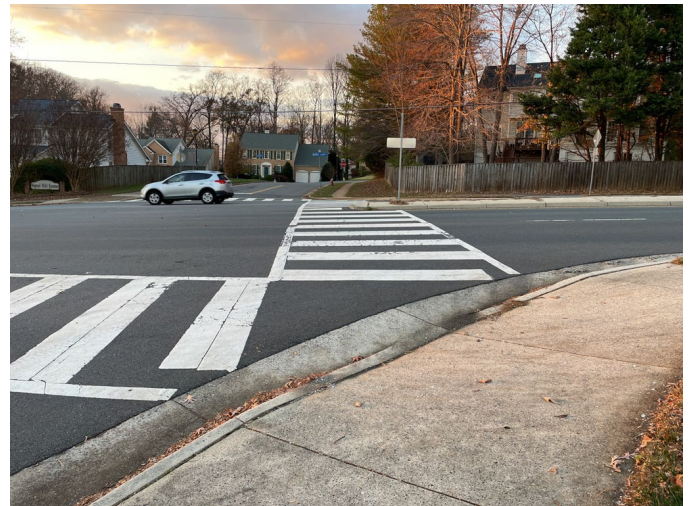
Burke Lake Road is an arterial roadway with high motor vehicle speeds and volumes. The speed limit at this location is 45 mph. The Burke Lake Road crossing is uncontrolled. Pedestrians must find a gap in fast-moving traffic and cross two lanes of through traffic in each direction, creating the potential for a multiple threat crash (Figure 24). Although there is a median on Burke Lake Road, it does not extend through the crosswalk, which means there is not a pedestrian refuge island where pedestrians can wait to make a two-stage crossing.

Figure 24: Uncontrolled crosswalk across Burke Lake Road at Signal Hill Drive.

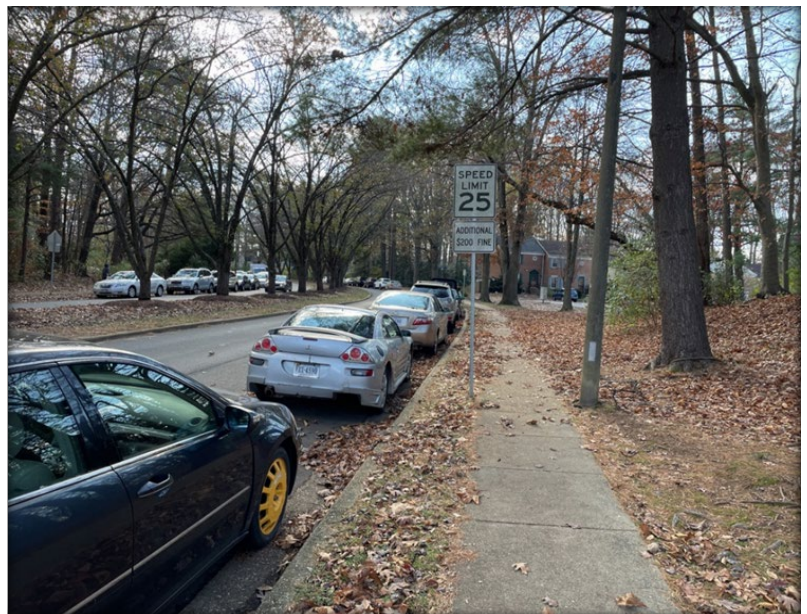
Figure 25: Sidewalk on Lake Braddock Drive

- Expand other sidewalks along corridor to 6 feet wide minimum.
- Consider reallocating roadway space to create space for bike lanes.

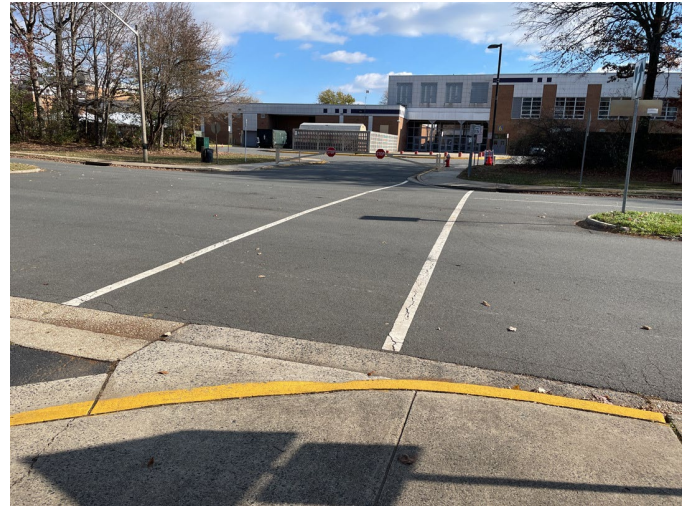
Figure 26: Crosswalk across Lake Braddock Drive at Mersea Court (north side).

This intersection is uncontrolled for traffic on Burke Lake Road (Figure 26), and there is no crossing guard to assist students crossing during arrival and dismissal times. The existing marked crosswalk across Lake Braddock Drive is not high-visibility and does not take advantage of the median to create a pedestrian refuge. The curb ramps that serve the crossing are not ADA-compliant, because they lack detectable warning surfaces and level landings.

- Construct permanent curb extensions with refuge island to support existing crosswalk. If study recommends RRFB, install concurrently.
- Upgrade curb ramps to comply with ADA guidelines.
- Consider installing marked crosswalk on north side of intersection.

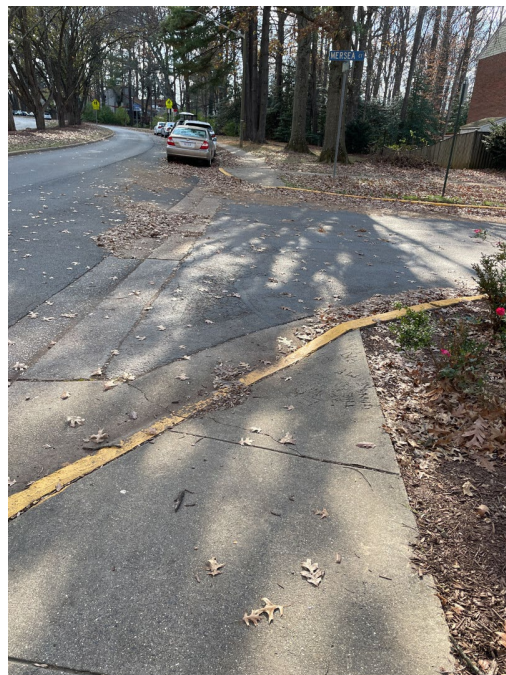
Figure 27: Crosswalk across Mersea Court (south side) at Lake Braddock Drive.

- Construct curb extensions on the northeast and southeast corners to reduce pedestrian crossing distances and slow motorists.
- Mark high-visibility crosswalks with ADA-compliant curb across Mersea Court.

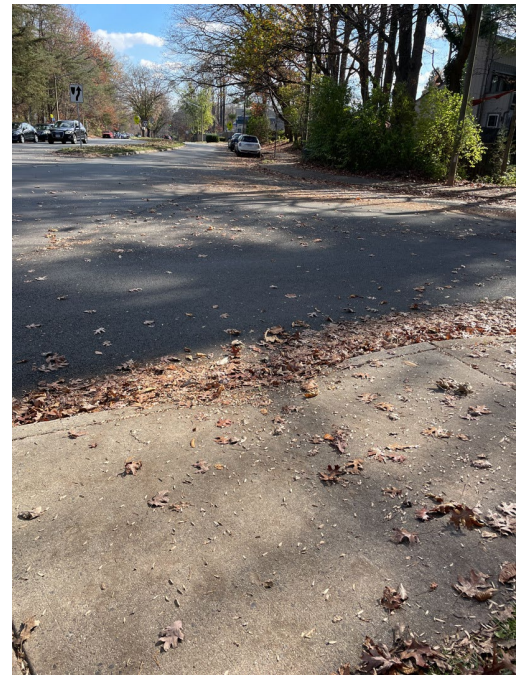
Figure 28: Crossing across Cotherstone Court at Lake Braddock Drive.

- Construct curb extensions on all corners to reduce pedestrian crossing distances and slow motorists.
- Mark high-visibility crosswalks with ADA-compliant curb ramps on all crosswalk legs.

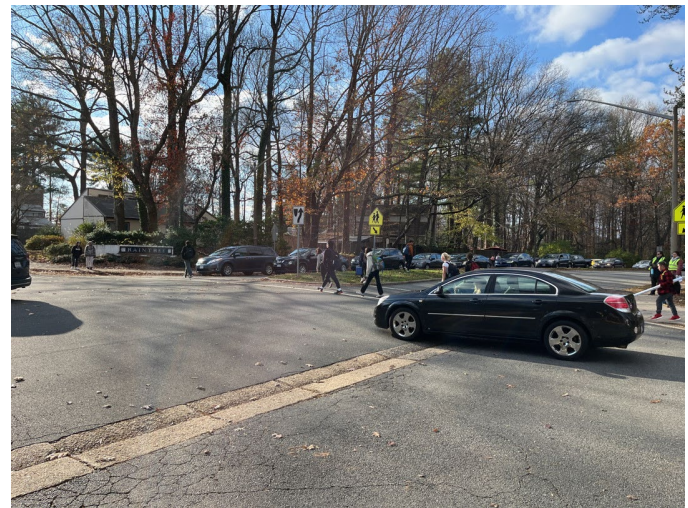
This intersection is uncontrolled for traffic on Burke Lake Road, and there is no crossing guard to assist students crossing during arrival and dismissal times (Figure 29). The existing marked crosswalk across Lake Braddock Drive is not high-visibility, does not encompass the curb ramp on the north side of the crosswalk, and is narrowed by the median, which extends into the crosswalk space without providing an accessible refuge.

Figure 29: Crosswalk across Lake Braddock Drive at Raintree Road.

The curb ramps that serve the crossing are not ADA-compliant, because they lack detectable warning surfaces.

- Construct permanent curb extensions with refuge island to support existing crosswalk. If study recommends RRFB, install concurrently.
Upgrade curb ramps to comply with ADA guidelines.

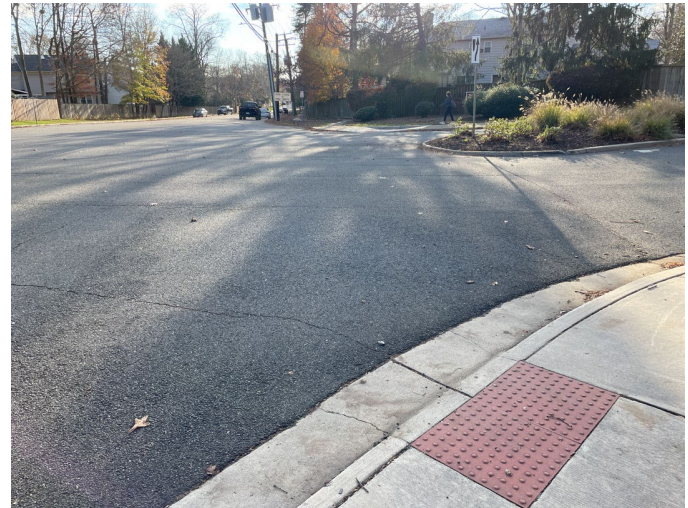
Figure 30: Crosswalk across Lake Braddock Drive at Old Burke Lake Road.

- Install curb extensions on the northwest, southwest, and southeast corners to reduce pedestrian crossing distance, reduce motor vehicle speeds, and improve visibility between motorists and crossing pedestrians.
- Add "nose" to median on north side of intersection to create pedestrian refuge island.

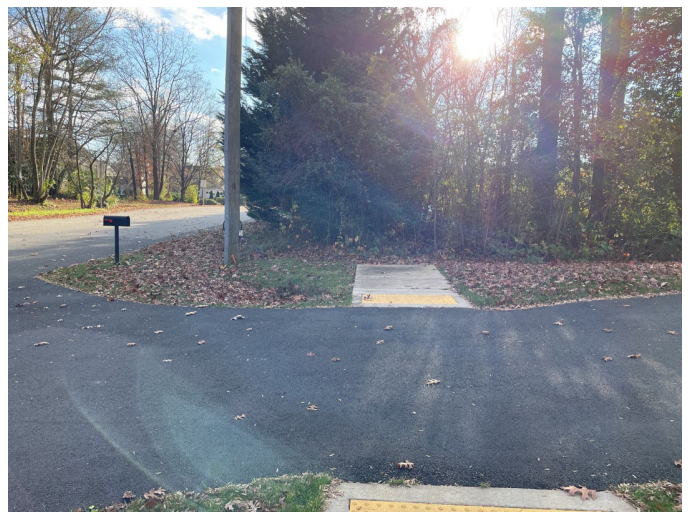
Figure 31: Sidewalk gap on Old Burke Lake Road.

- Address sidewalk gap by constructing sidewalk in front of 9224 Old Burke Lake Road.
