**Virginia Department of Transportation
X Tension Tangent 37.5' (11.43 m) System**

TR-P36134-01-NC

Test Article: X Tension Tangent 37.5' (11.43 m) System Project No. P36134-01
 Test Program: 100 km/h 5° Guardrail Terminal Impact Test Test Date: 08/18/16

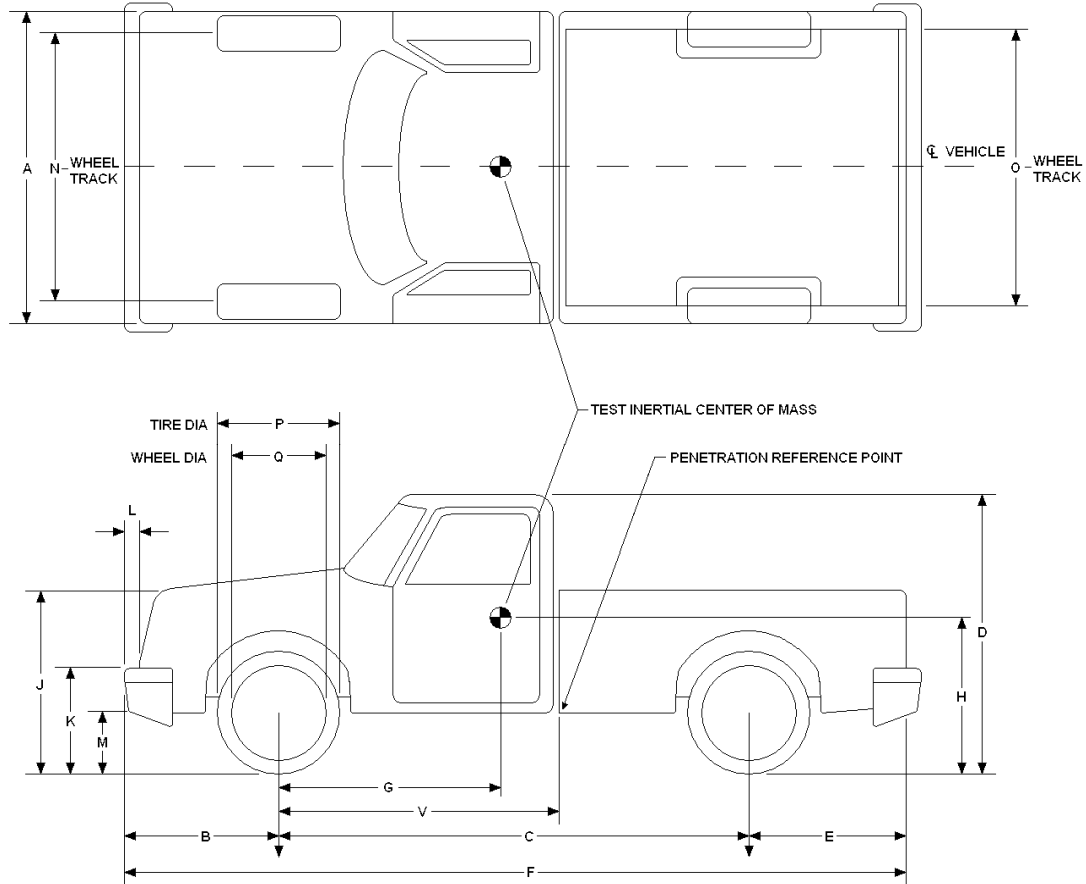
TEST VEHICLE GEOMETRY

mm	in.		mm	in.		mm	in.		mm	in.
A	2001	78.8	E	1159	45.6	J	1100	43.3	N	1755	69.1
B	992	39.1	F	5534	217.9	K	790	31.1	O	1685	66.3
C	3383	133.2	G	1335	52.6	L	85	3.3	P	750	29.5
D	1920	75.6	H	728	28.7	M	465	18.3	Q	440	17.3

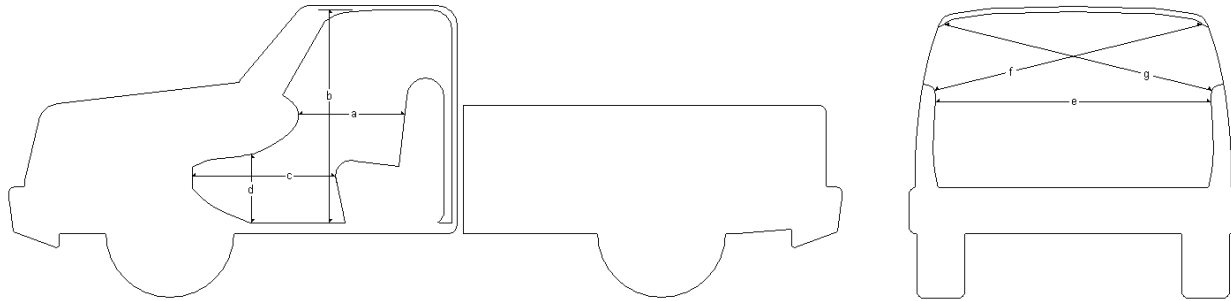
The seven subindices a, b, c, d, e, f and g indicate the percentage of reduction of seven interior dimensions shown on the following figure:

- a = distance between the dashboard and a reference point at the rear of the occupant compartment, such as top of rear seat, or the rear part of the cab on a pickup;
- b = distance between the roof and the floor panel;
- c = distance between a reference point at the rear of the occupant compartment and the motor panel;
- d = distance between the lower dashboard and the floor panel;
- e = interior width;
- f = distance between the lower edge of right window and the upper edge of left window; and
- g = distance between the lower edge of left window and the upper edge of right window

Sub-Indices	Pre-Test		Post-Test		Percent Reduction
	mm	in.	mm	in.	
A	1049	41.3	1050	41.3	-0.10%
B	1137	44.8	1125	44.3	1.06%
C	1617	63.7	1612	63.5	0.31%
D	393	15.5	394	15.5	-0.25%
E	1720	67.7	1728	68.0	-0.47%
F	1603	63.1	1610	63.4	-0.44%
G	1576	62.0	1574	62.0	0.13%
Max Deformation	1137	44.8	1125	44.3	1.06%
OCDI	FS0000000				
Comments:	None

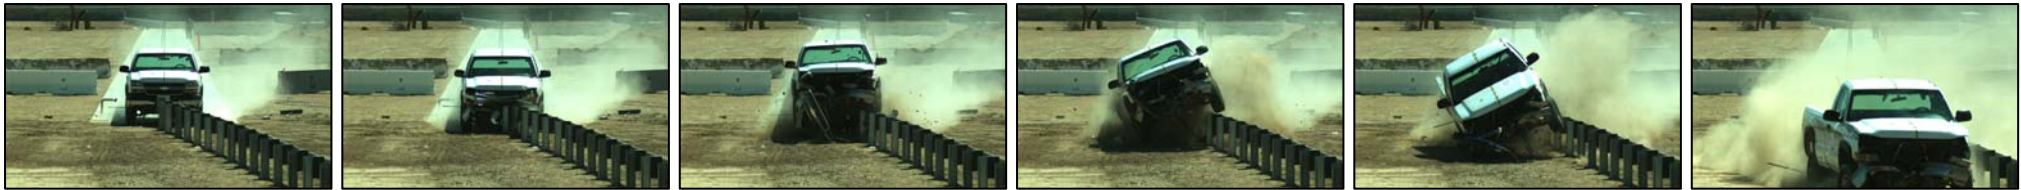
DATA SHEET 4
SUMMARY OF RESULTS

0 ms 200 ms 500 ms 750 ms 1033 ms 2400 ms

The test vehicle impacted the X Tension Tangent 37.5' (11.43 m) System at a velocity of 99.19 km/h (61.63 mph). The test vehicle impacted the X Tension impact head and pushed rail 1 down rail 2. When the slider panel reached rail 3 the shear bolts connecting rail 2 and 3 were sheared. Rail 1 came to rest approximately mid span between post 5 and 6. The vehicle continued to the non traffic side of the article. The vehicle began tracking toward the article and impacted the non-traffic side of the system between post 21 and 22. The vehicle came to rest 46.1 m (151.2 ft.) downstream from the initial impact point and resting on the non-traffic side of the article. As a result of the impact the article sustained damage from post 1 through 7. Post 1 folded to the ground, post 2 tore at the crimp and post 3 and 4 bent towards the ground. The impact head and slider bracket sustained deformation. The top cable tore at the face of the impact head. An overhead illustration of the test vehicle and test article in their pre-test and post-test condition is shown in figure 2 in Appendix D. Sequential photographs of the test sequence are shown on Data Sheet 4.

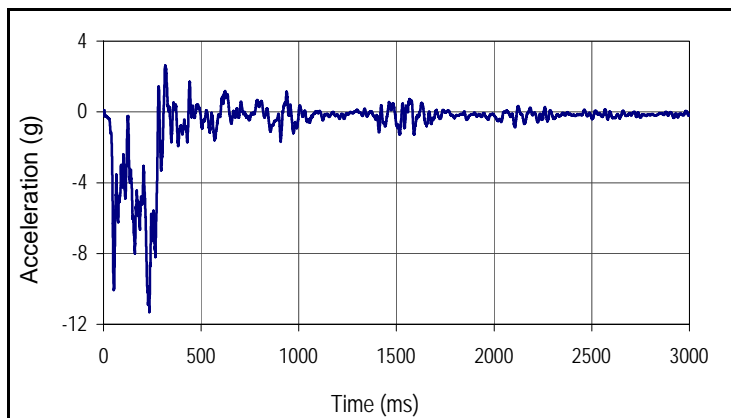
Curve Description			
Test Vehicle CG X Moving Average			
Plot No.	Type	SAE Class	Units
002	AVG	180	g
Max	Time	Min	Time
2.6	316.2	-11.3	234.1
